Upper Stillwater River Assessment

Prepared by:
Warren Kellogg
Stream & Watershed Consulting
38 Hidden Valley Drive, Clancy, MT 59634
March 2014

Stillwater Valley Watershed Council
and
Stillwater Conservation District

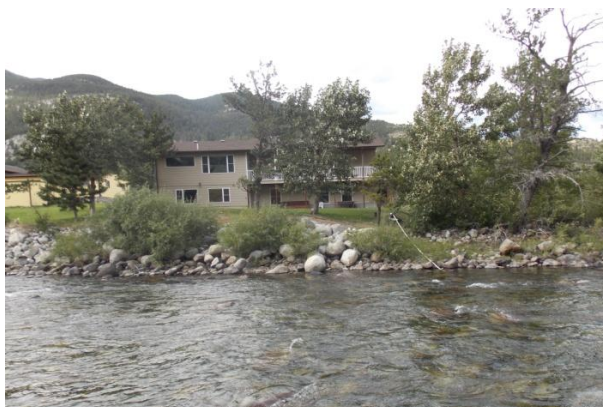
Subdivision with 12 small tracts along 0.3 miles of the west river bank. The subdivision was developed in the 1960s. Most tracts have houses on or near the river's edge usually with some form of bank stabilization: rock rip-rap, flow deflectors (jetty) and/or floodplain dikes. Small irrigation pumps in the river are used for landscape watering. The riparian vegetation has been cleared to varying degrees to accommodate landscaping.

Individual small tract impacts to channel stability, in-stream flow, and water quality are usually minimal, but cumulatively they pose a significant risk to the Stillwater River.

Small tracts: House on river's edge with bank stabilization and a small irrigation pump.

Recommendation: Develop and implement a small tract outreach and assistance program to help landowners better understand how to minimize their impacts on the river. Program topics would include noxious weed management, water rights, septic maintenance, riparian vegetation, suitable building locations, and basic river dynamics.

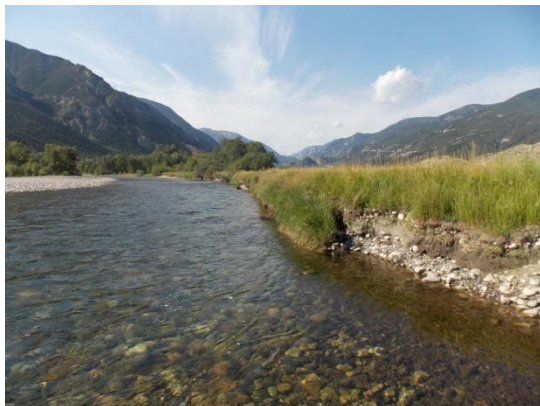
Site SW-19 Accelerated Bank Erosion**Priority: Medium***(Stillwater River – Map #2)*

Active bank erosion on approximately 200 feet of bank (~ 6 feet high) along a subirrigated hay field on the west side of the river. The bank has eroded nearly 40 feet in the last 15 years, and 100 feet over a 50 year period. A high water side channel on the downstream end of the bank erosion circles to the west. Two factors are contributing to the bank erosion: 1) the upstream rip-rapped river banks (Sites 17, 18, and 19) has restricted the river channel and directed the main current towards this bank and; 2) a large gravel bar has formed on the opposite bank that will continue to build and push the river west. If the bank is allowed to erode into the side channel, the side channel may eventually become the main river channel.

Active bank erosion along a hay field on the west side of the river. Rock rip-rapped banks upstream and a large gravel bar on the opposite bank are contributing to the erosion.

Recommendation: Install approximately 200 feet of rock rip-rap from the mouth of the side channel going upstream. Incorporate a small flow deflector at the downstream end of the rip-rap, just above the mouth of the side channel. Use well-placed angular rock on a 3:1 shaped bank. Keep the side channel open allowing high water access. Plant cottonwood and willow transplants and cuttings behind the rip-rap for long-term stability.

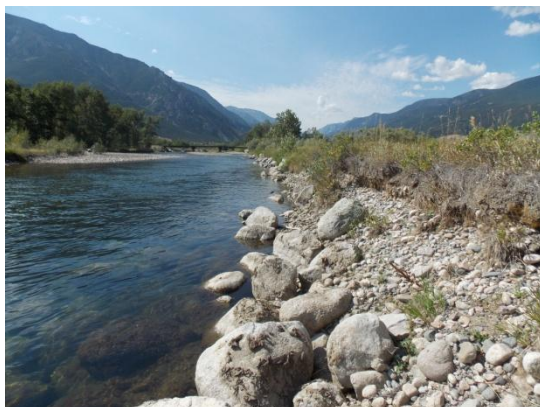
Site SW-23 Bank Stabilization - Rock Rip-Rap**Priority: Medium***(Stillwater River – Map #3)*

Downstream from the bridge (SW-22), approximately 170 feet of rock rip-rap lines the west bank. The rip-rap was installed about 15 years ago. It is partially functional and does not extend far enough upstream. Behind the rip-rap, a 70 – 100 foot wide riparian buffer separates the river and hay field.

Rock rip-rap has scoured out and is only partially functional. Additional rock is needed to protect the bank.

Recommendation: The existing rip-rap will need to be reinforced with additional rock (preferably large angular rock) and extended 50 – 60 feet upstream where the main current crosses a diagonal channel bar and directly impacting the west bank.

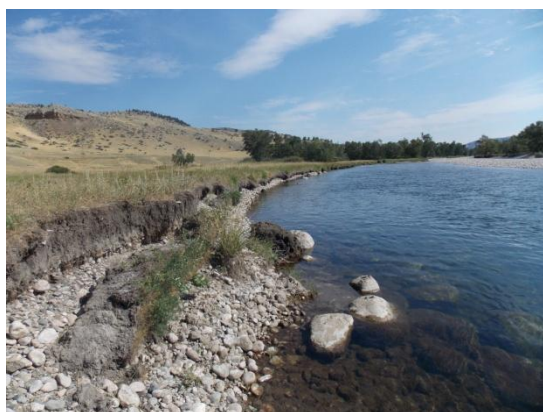
Downstream from the SW-23 rock rip-rap, there is approximately 550 feet of active bank erosion. This bank was previously protected by rock rip-rap that has since failed and sloughed off into a deep pool. Since 1963, the river has eroded approximately 70 feet into an adjacent hay field. In the last 15 years, it moved about 20 feet.

Bank erosion along a hay field on the west side of the river. Previously placed rock rip-rap has sloughed into the channel.

An initial step would be to do a detailed survey of the area to quantify channel migration rates into the floodplain to determine the cost/benefits of installing rip-rap. This survey would document active headcutting and elevation differences between the old channel traces on the west floodplain and the current river channel. Refer to the Reach 2 recommendation where the Site SW-24 survey could be done as part of a larger reach assessment.

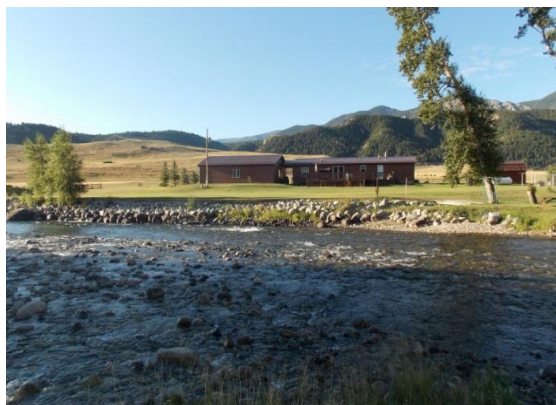
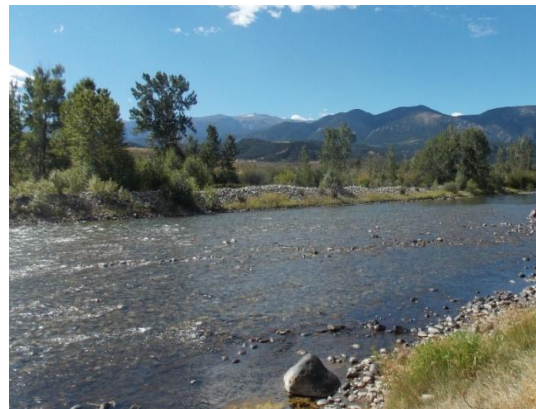
Long gravel dikes have restricted high water access to parts of the historic floodplain. These dikes are old and were constructed prior to the land being subdivided. They continue to not only affect the abandoned floodplains, but are indirectly impacting property downstream and across the river.

Riparian vegetation is often cleared on small tracts (left photo). Bank stabilization eventually becomes necessary when the banks are left unprotected. Gravel dikes pushed up along the river's edge prevent high flows from accessing the historic floodplain (right photo).

Recommendation: Develop and implement a small tract outreach and assistance program to help landowners better understand how to minimize their impacts on the river. Program topics would include noxious weed management, water rights, native riparian vegetation, septic maintenance, suitable building locations, and basic river dynamics.

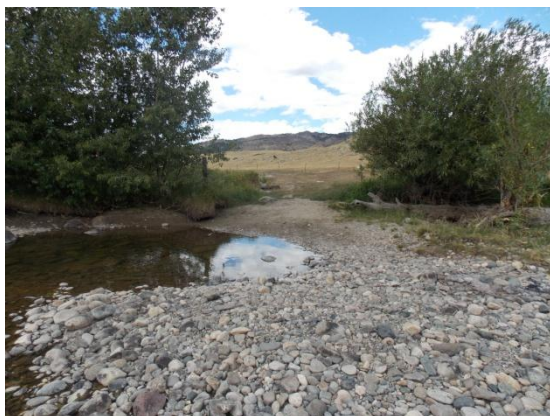
Site SW-41 Boat Ramp – Montana FWP Moraine Fishing Access Site**Priority: Low***(Stillwater River – Map #5)*

Dirt boat launch at the Moraine Fishing Access Site (60 acres). The boat launch is in poor condition. A gravel bar has formed at the end of the ramp making it difficult to launch rafts.

Dirt boat ramp at the Moraine Fishing Access Site.

Recommendation: Reconstruct the boat launch site to better accommodate recreational use and high water impacts. The boat ramp should be relocated downstream about 250 feet. The Old Nye FAS (Site SW-14) would serve as a good template.

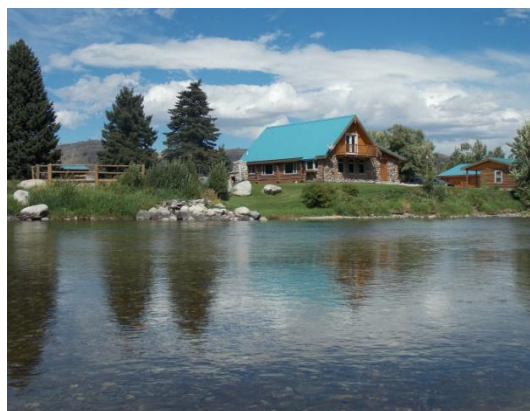
This subdivision included 12 small tracts along 0.9 miles of the northwest side of the river. The land was subdivided in the 1980s and 1990s into tracts that vary in size from 4 – 20 acres. All but two tracts have been developed. Most houses were built on the terrace bench within 100 feet off the river's edge. Their close proximity to the river has compelled several tract owners to install bank stabilization (rock rip-rap and jetties), clear native riparian vegetation and place pumps in the river for landscape irrigation.

Rock jetty on upstream side of landscaped yard.

Recommendation: Develop and implement a small tract outreach and assistance program to help landowners better understand how to minimize their impacts on the river. Program topics would

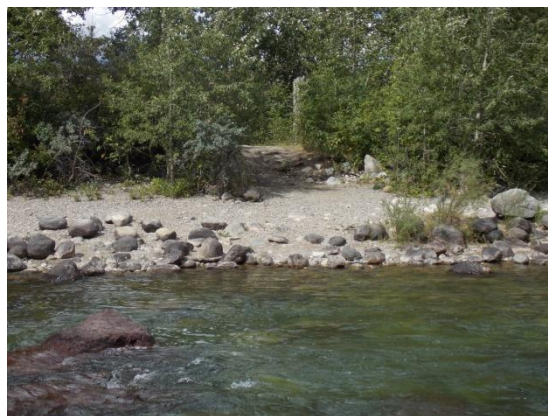
Dirt boat ramp at the Castle Rock Fishing Access Site (80 acres). The ramp is steep and in need of repair.

Dirt boat ramp at the Castle Rock Fishing Access Site.

Recommendation: Reconstruct the boat ramp to better accommodate recreational use and high water impacts. The Old Nye FAS (Site SW-14) would serve as a good template.

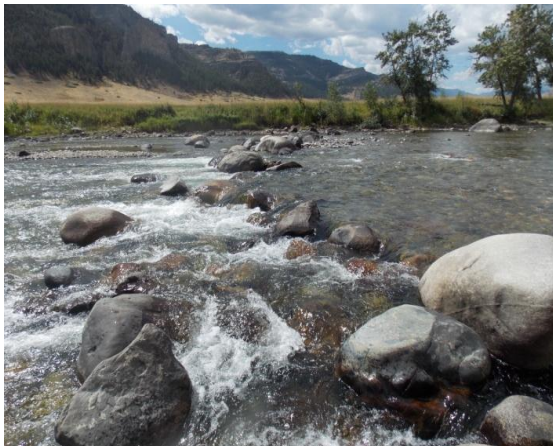
Irrigation cross-channel rock diversion and concrete headgate. The rock diversion extends 140 feet across the river. It is a low-head dam that raises the water 1 – 2 feet during low flows. Some rock has slipped off the structure either because of ice or high water.

Cross-channel rock diversion at the head of the Dyer Ditch.

Recommendation: Replace the headgate and by-pass structure. The new structure should include a much wider by-pass outlet that will accommodate passage of woody debris. Consider shortening the inlet canal and moving the rock diversion downstream approximately 200 feet.

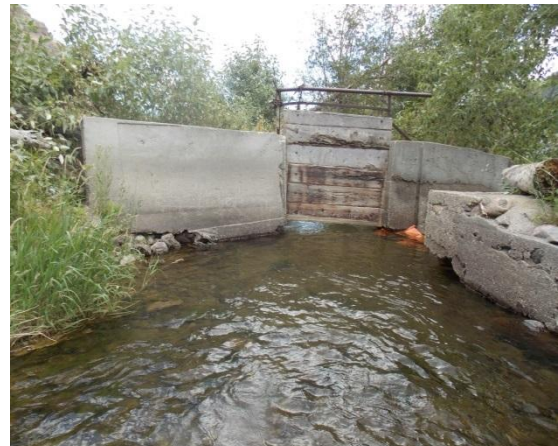
The upper ditch is inset in the river channel, paralleling the north bank. The upper 200 feet requires periodic maintenance after high water events. A concrete headgate and by-pass structure are located 500 feet down the open-inlet ditch. The headgate has a wood slide gate to control flows into the ditch. The by-pass outlet, next to the headgate, is about 3 feet above the river and can be checked up with boards. The outlet opening is narrow and does not provide for passage of large floating debris. The overall condition of the structure is poor; the wing walls and outlet apron are being scoured. The priority dates of the Dyer Ditch water rights range from 1910 to 1954.

Concrete headgate and by-pass structure about 500 feet down the ditch.

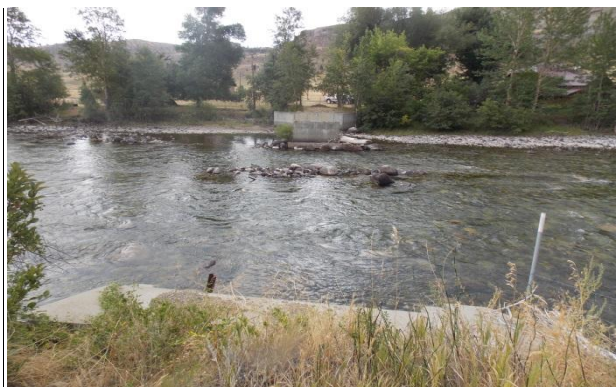
A bridge was once located on the Lower Midnight Road and used as recently as 15 years ago. The bridge and one support were removed in the late 2000s; both concrete abutments and a second mid-channel bridge support remain. The north abutment has been undercut and is leaning into the river. The mid-channel bridge support is 40 feet from the south abutment and may pose a safety hazard to floaters during high flows.

Old bridge abutments with a mid-channel support near the south bank.

Recommendation: Remove the mid-channel bridge support from the river.

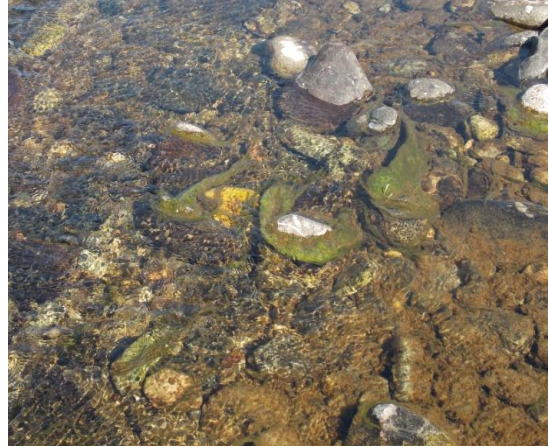
The subdivision has a high number of retaining walls bordering the river. Most tracts have pumps in the river for landscape irrigation.

Filamentous algae are prominent along this reach.

Recommendation: Develop and implement a small tract outreach and assistance program to help landowners understand how to minimize their impacts on the river. Program topics would include noxious weed management, water rights, septic maintenance, suitable building locations, and basic river dynamics.

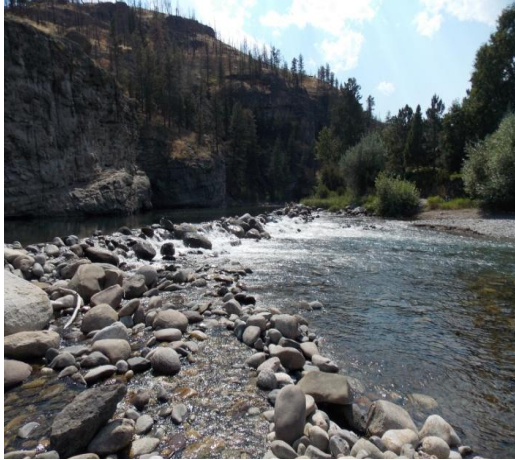
Gravel/cobble cross-channel diversion pushed up each year following high water.

To take pressure off the canal, allow passage of ice and bedload, and reduce the hazard to rafters, a chute could be incorporated into the weir. The chute opening would be at least 80 feet wide although the location and opening width would need to be determined by a detailed hydrology/hydraulic analysis. During the irrigation season when flows are low, portable pre-cast concrete blocks would be placed in the chute to check the water up to the needed elevation. It would take about 15 blocks (1500 – 2000 lbs. each) to fill the gap. The blocks can be cast in a wide variety of sizes, shapes, and weights to fit the diversion alignment, stream velocity, and equipment lift capacities. These blocks would be placed after summer run-off and removed in the fall following the irrigation season. A firm bed would be maintained to allow equipment (front end loader) to place and remove the blocks. This recommendation requires additional operational time and expense each year to make the system functional, but it would eliminate the on-going expense and impacts of reconstructing a gravel diversion each year.

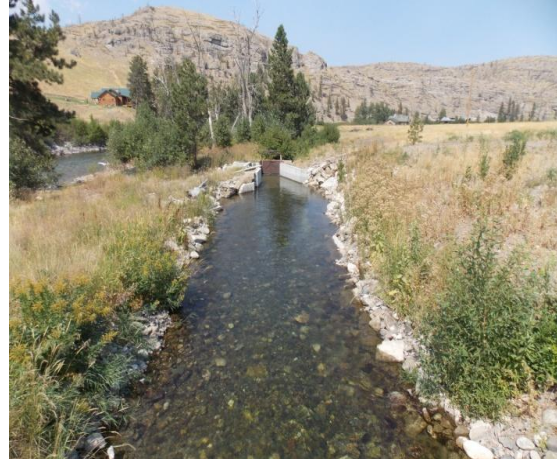
The concrete headgate/by-pass structure is located 100 feet below the county bridge on the east side of the river. The headgate (concrete w/metal screw gate) has recently been replaced. Floating debris tends to hang up at the structure because the by-pass outlet is too narrow and the slide gate is inset too far.

Headgate and by-pass structure in the canal, north of the county road.

- 2) The water users need to make adjustments on their new headgate/by-pass structure. The slide gate should be moved forward to minimize woody debris hanging up on the structure. The by-pass outlet needs to be widened to pass larger debris.

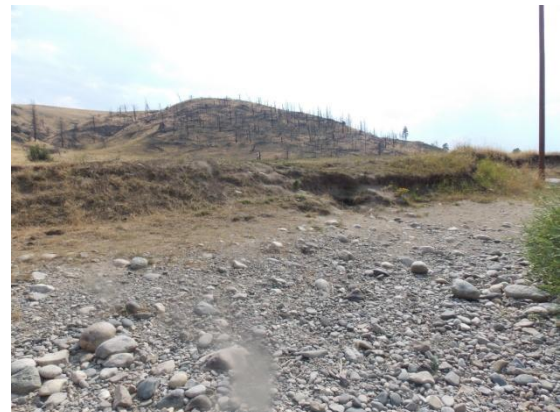
Dirt boat ramp at the Cliff Swallow Fishing Access Site (160 acres) on the south side of the river. The launch ramp is located at the downstream end of the Fishing Access Site. It is a difficult launch site with a 3 – 4 foot drop off the terrace bank.

Launch area at the Cliff Swallow Fishing Access Site.

Recommendation: Reconstruct the boat ramp to better accommodate recreational use and high water impacts. The Old Nye FAS (Site SW-14) would serve as a good template.

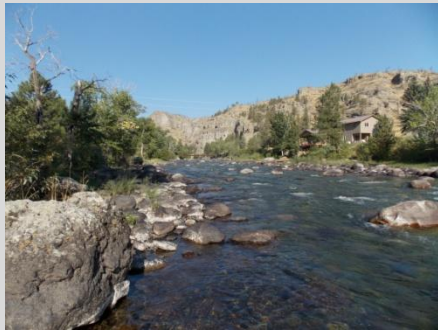
Near Site SW-64. This reach is a canyon section surrounded by hard volcanic bedrock. The river is a single-threaded channel with a narrow floodplain and riparian corridor. Small tract development is especially dense along this reach.

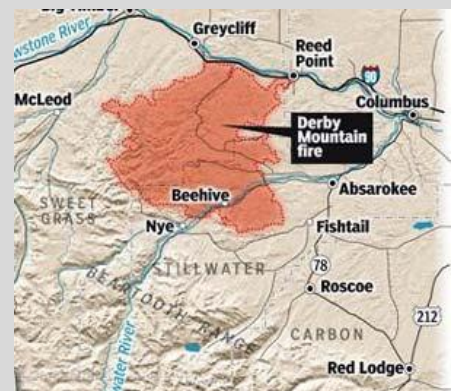
Noxious weed infestations expanded substantially following the Derby Fire. Spotted knapweed plants and leafy spurge plants are common along the river fringe and adjacent terrace banks.

The 2006 Derby Mountain Fire burned across the Stillwater River along most of this reach.

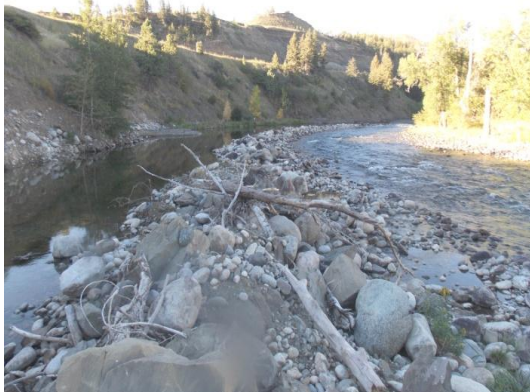
The gravel/cobble wing diversion extends about 400 feet upstream from the mouth of the delivery canal. The diversion requires periodic maintenance and reconstruction after high water events. The 400 foot long delivery canal is stable and well vegetated.

Long gravel/cobble wing diversion extending upstream from the delivery canal and headgate.

To take pressure off the weir, allow passage of ice and bedload, and reduce the hazard to rafters, a chute could be incorporated into the weir. The chute opening would be at least 80 feet wide although the exact opening width and location would need to be determined by a detailed hydrology/hydraulic analysis. During the irrigation season when flows are low, portable pre-cast concrete blocks would be placed in the chute to check the water up to the needed elevation. It would take about 15 blocks (1500 – 2000 lbs. each) to fill the gap. The blocks can be cast in a wide variety of sizes, shapes, and weights to fit the diversion alignment, stream velocity, and equipment lift capacities. These blocks would be placed after summer run-off and removed in the fall following the irrigation season. A firm bed would be maintained to allow equipment (front end loader) to place and remove the blocks. This recommendation requires additional operation time to place and

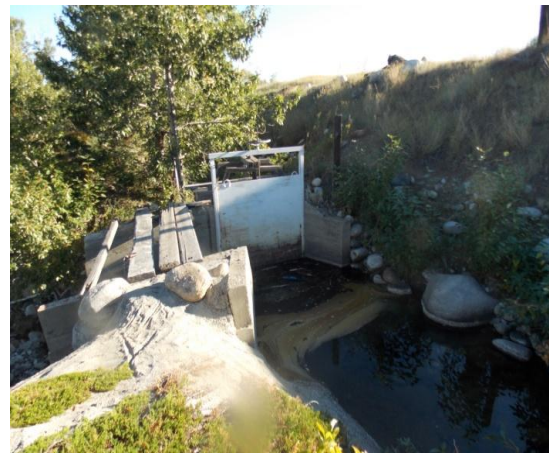
The headgate structure has been reinforced with concrete and an old wooden gate was replaced with a steel slide gate. The by-pass outlet is at a 90° angle to the headgate with a narrow opening that can be checked up with boards. The open canal and structure catch a large amount of floating debris during high flows. The outlet apron is being scoured.

Irrigation headwall and metal slide gate with a by-pass outlet on the left.

- 3) Option: Consolidate the Yanzick Ditch infrastructure with the Brey-Riddle Ditch. The two headwalls are only 125 feet apart. Consolidation of ditches is sometimes a difficult path: initial expense, sorting out operational responsibilities, and maintaining individual water rights. But, it is not impossible and there can be several benefits. With this option there would be a headgate, diversion and ditch (700 feet) before splitting off into existing laterals. The capacity of the headgate and ditch would likely need to be increased to deliver sufficient water to all water users. This option has the benefit of significantly reducing long-term maintenance costs and impacts to the river.

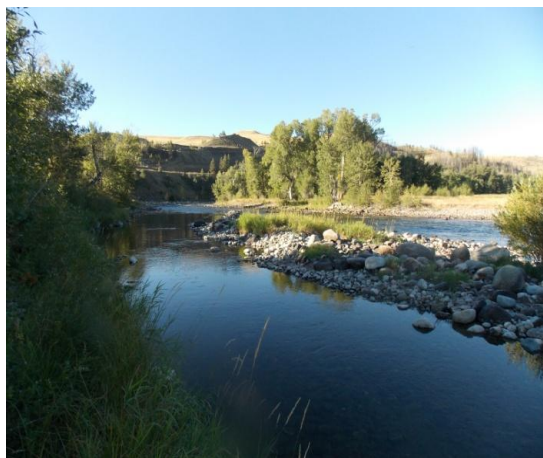
There is a short section of rock rip-rap and minor bank scouring on the opposite bank. The bank scour may be caused by the two gravel wing walls from the Yanzick and Brey-Riddle diversions.

Gravel/cobble wing diversion extending upstream and partially across the river.

Recommendation: Same general recommendation as for Site SW-77 (Yanzick Headgate/Diversion)

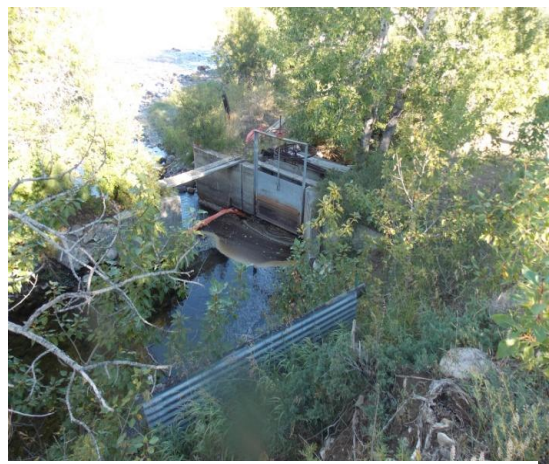
Irrigation headwall and metal screw gate with a by-pass outlet on the left.

- 2) The water users need to make adjustments on their headgate/by-pass structure. The by-pass outlet should be widened to better pass debris and the wing wall footings need to be patched.
- 1) Option: Consider the possibility of consolidating this infrastructure with the Yanzick Ditch. The two headwalls are only 125 feet apart. Consolidation of ditches is sometimes a difficult path: initial expense, sorting out operational responsibilities, and maintaining individual water rights. But, it is not impossible and there are several benefits. With this option there would be a common headgate and ditch (700 feet) before splitting off into existing laterals. The capacity of the headgate and ditch would likely need to be increased to deliver sufficient water to all water users. This option has the benefit of significantly reducing long-term maintenance costs and impacts to the river.

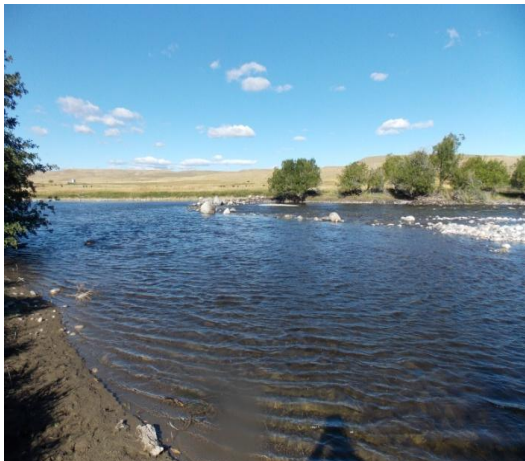
The boulder/cobble wing diversion extends 220 feet across the river, aligned in an upstream arc. It raises the water to 2 feet, diverting flow into the east side channel towards the headgate. The cross-channel diversion is built with a variety of rock sizes ranging from small gravel to large boulders. The diversion requires varying degrees of reconstruction after high water events.

Rock diversion extending across the river at the head of the side channel.

Recommendation: The cross channel rock diversion and headgate structure are well laid out. To make it more permanent, large rock would replace the gravel and cobbles currently being used in the diversion. This would reduce the need for equipment to be in the river reconstructing the diversion after most high water events.

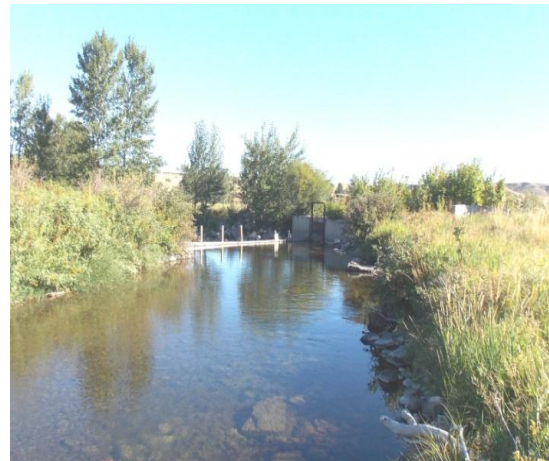
The concrete headgate has a steel screw gate and a check structure that spans the side channel (18 feet). Boards are used in the check structure to elevate the water into the headgate and ditch. The alignment and wide opening of the check structure provide clear passage of floating debris.

Irrigation headgate and check structure on the side channel.

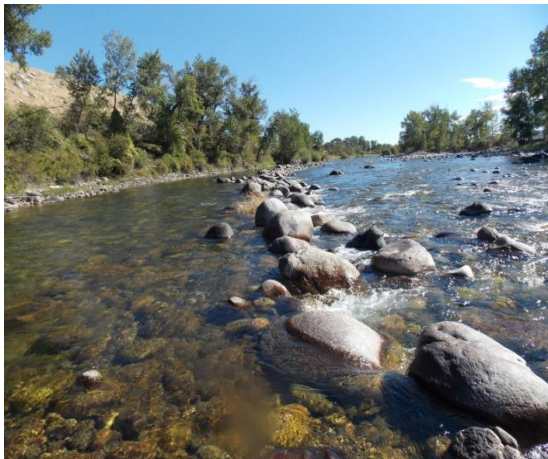
The boulder/cobble wing diversion extends 400 feet upstream and across the river. It raises the water level about 2 feet, diverting flow into the north delivery ditch and headgate. The wing diversion is built with a variety of rock sizes ranging from gravels to small boulders. It requires maintenance and replacement of rock after most high water events.

Long rock wing diversion extending upstream and across the river.

To provide passage of floating debris and bedload, a by-pass chute should be incorporated into the weir close to the headgate. The chute opening would be at least 60 feet wide; however, the optimal opening size would be determined by a detailed hydrology/hydraulic analysis. During the irrigation season when flows are down, portable pre-cast concrete blocks would be placed in the gap to check the water up to the needed elevation. It would take 10 – 12 blocks (1500 – 2000 lbs. each) to fill the gap. The blocks can be cast in a wide variety of sizes, shapes, and weights to fit the diversion alignment, stream velocity, and equipment lift capacities. These blocks would be placed after summer run-off and removed in the fall following the irrigation season. A firm bed would be maintained to allow equipment (front end loader) to place and remove the blocks. This recommendation requires additional operation time to place and remove the blocks each year, but it would eliminate the on-going expense and impacts of maintaining a gravel/cobble diversion after high water events.

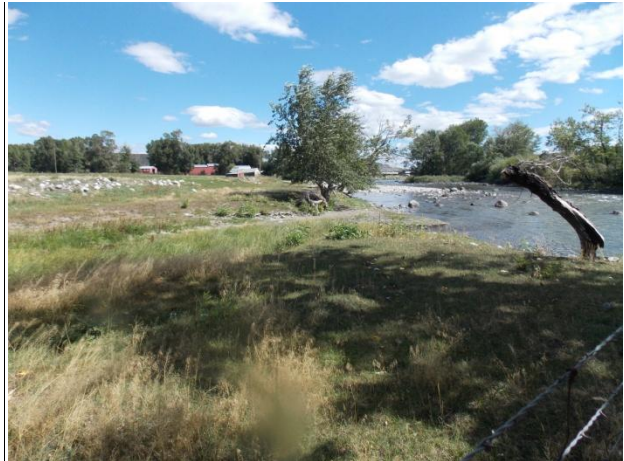
On the lower half of Site SW-83, small pastures are unfenced from the river. The riparian vegetation consists of scattered mature cottonwood trees and an understory of grass and bare soil. A pile of old farm implements, metal scrap, and wood on the bank acts as a jetty creating a large downstream eddy. A 40 x 80 foot section of bank has eroded away because of the eddy.

Small pasture next to the river.

- 1) Construct a riparian fence (permanent or portable electric) along the river corridor to allow for riparian recovery. Incorporate water gaps or develop an off-stream livestock water alternative. Planting young cottonwood cuttings would speed the recovery.
- 2) Remove the pile of implements, scrap metal, and wood from the river bank to stop the downstream eddying and bank erosion. Trim low tree branches that are catching floating debris. Fill in the eroded area with gravel topped with soil. Re-vegetate with young willows and cottonwood saplings.

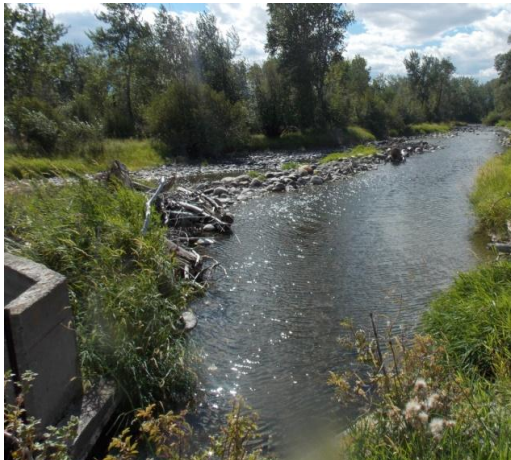
The headwall structure is old and in poor condition. The concrete headgate has a metal slide gate with a narrow by-pass outlet. The by-pass outlet is too narrow and poorly aligned to effectively pass floating debris. Debris tends to accumulate in front of the structure.

Rock wing diversion extending upstream from the headgate on the north channel.

- 1) Replace the headgate and diversion. A new headgate and diversion would be designed to pass bedload and floating debris using a similar layout as shown for the Larson-Johnson headgate (Site SW-80).
- 2) Construct a permanent cross-channel weir (red dashed line on photo below) to divert water to the headgate. The weir (120 feet) would arc upstream, extend across the side channel and tie into the island's north bank. Large footer rocks would be keyed into the river bed and overlain with large rocks to raise the water level to the necessary elevation at the headgate.

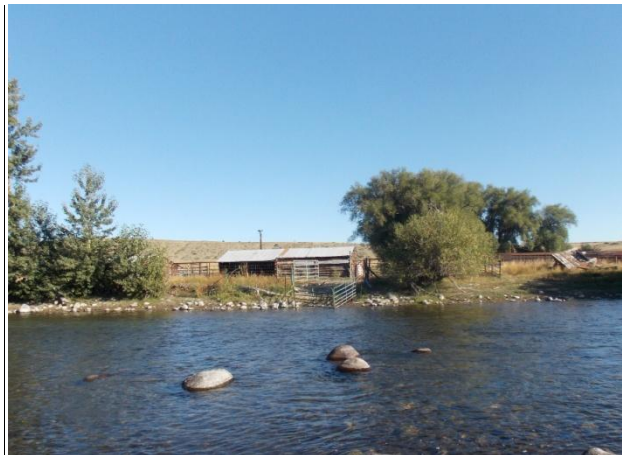
Corrals and small pens located on an inside bend and low floodplain, north side of the river. A 10 – 30 foot buffer separates the corrals from the river. During high precipitation and snow melt events, nutrients from the corrals may reach the river through surface run-off or from leaching into the shallow water table. A livestock water gap is incorporated in with the corrals. Old aerial photography shows these corrals in the same location for at least 60 years.

Corrals located on the low floodplain with a small livestock water gap.

NRCS may be willing to complete an evaluation of the corral system to suggest options to reduce the amount of nutrients entering the river. One option is to widen the riparian buffer to 50 feet by relocating the corral pen currently next to the river to the north side of the existing corrals. Additional water development may be necessary if the water gap is removed.

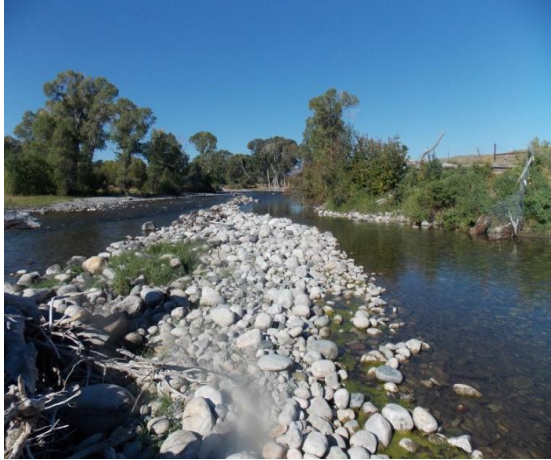
An irrigation headgate and check structure on the north side of the river. The ditch's water rights date back to 1891. A gravel/cobble wing diversion extends 400 feet upstream and across the river. The wing diversion directs water into a well vegetated canal (300 feet long) and headgate/by-pass structure. The wing diversion likely requires maintenance or replacement following most high water events.

Gravel/cobble wing diversion extending upstream from the delivery ditch and headgate.

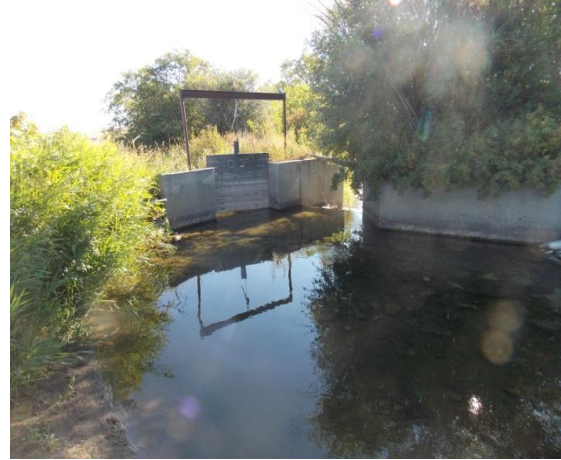
The concrete headwall has a wood slide gate and narrow by-pass opening. The structure is in good condition and functions well. Floating debris does not appear to be a problem. There is a 25 foot wide opening in the ditch wall about 40 feet up from the headgate which may pass most of the debris that enters the upper ditch.

Concrete headgate with a wood slide gate and by-pass.

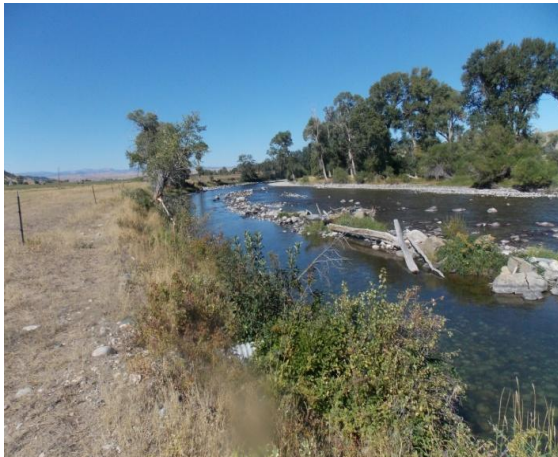
The gravel/cobble wing diversion extends 500 feet upstream and across the river. The diversion requires occasional maintenance and replacement of rock after high water events.

Rock wing diversion extending 500 feet upstream from the Mendenhall Ditch headgate.

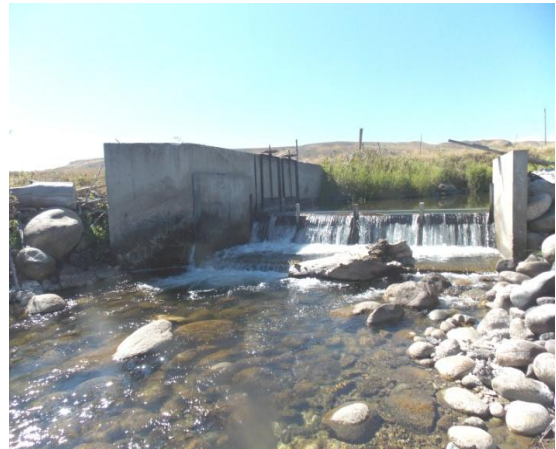
The concrete headwall is 40 feet wide and has two screw gates. The by-pass structure next to the headgate is 20 feet wide. The wide opening and alignment of the by-pass structure allows most bedload and floating debris to pass freely. The structure can be blocked with boards to elevate water into the headgate. There is about 3 feet of elevation difference between the by-pass opening and the river channel. Recent repairs were completed in 2001.

Concrete headgate and by-pass structure. The width and alignment of the by-pass accommodate passage of most floating debris.

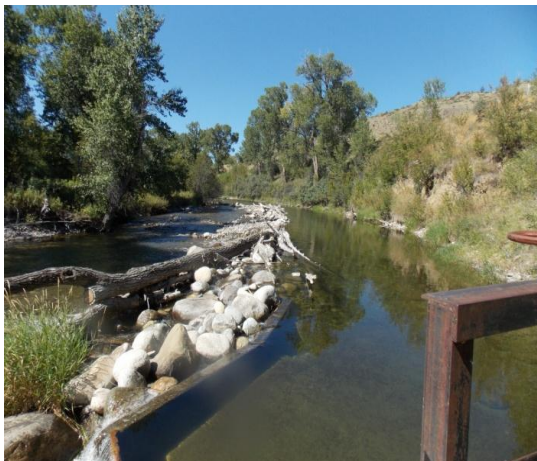
The wing diversion, extending 150 feet upstream, is built with rock that varies from small gravel to 2 foot diameter boulders. It may require maintenance or partial reconstruction following high water events.

The J. Kern headgate located on the north channel of a braided section of river. The photo is looking upstream at the rock wing diversion.

The headgate's wing walls and inlet apron are in need of repair to prevent further scouring and damage.

variety of sizes, shapes, and weights to fit the diversion alignment, stream velocity, and equipment lift capacities. These blocks would be placed after summer run-off and removed in the fall following the irrigation season. Bedload and floating debris would easily pass during high water and ice would be less of a problem in the winter. A firm bed would be maintained to allow equipment (front end loader) to place and remove the blocks. This recommendation requires additional operation time to place and remove the blocks each year, but it would eliminate on-going expenses and impacts of reconstructing a temporary rock wing diversion after each high water event.

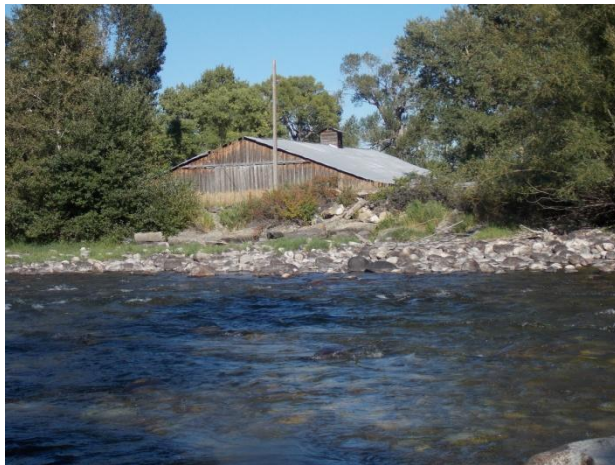
Rock rip-rap on the southeast bank next to a farmstead and corrals. The rock varies in size from cobbles to large angular rock along 600 feet of river bank. The rip-rap is old, but still intact. Riparian vegetation is growing up through the rocks. The rip-rap provides a narrow buffer between the corrals and the river.

Rock rip-rap provides a narrow buffer between the farmstead and the river.

Request that NRCS complete an evaluation of the corral system to determine if the corrals are contributing excessive nutrients to the river. If mitigation is recommended, options may include widening the riparian buffer and diverting surface drainage away from the river.

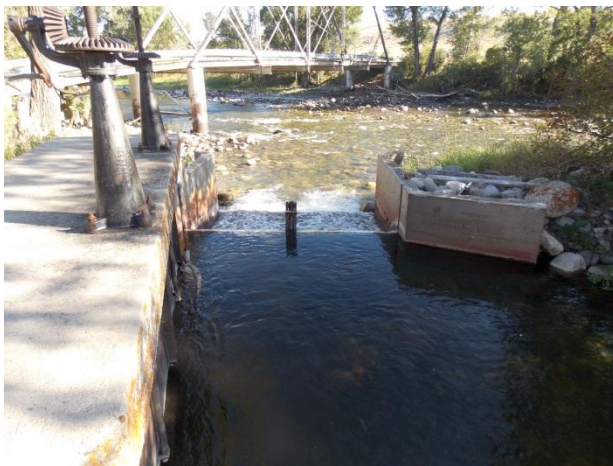
Irrigation headgate on the north river bank, immediately upstream from the Johnson Bridge. The concrete headgate and by-pass structure are old, but in good condition. The headwall has two screw gates. The by-pass has a 10 foot wide opening that can be checked up with boards. There is about 3 feet of elevation difference between the headgate inlet and the river.

The headgate structure is located on an inside bend where the river's main current is naturally directed towards the opposite bank. This is not an ideal location for this structure, creating an ongoing dilemma for the water users in getting sufficient water to their headgate. The water users have extended the wing diversion far enough upstream to catch the current before it crosses over to the south bank.

Garrigus Ditch headgate and by-pass structure. The Johnson Bridge is in the background..

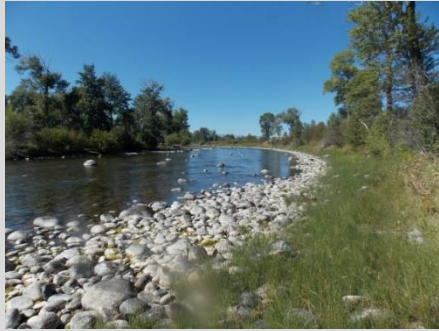
Cobble lined river channel. Photo taken near Site SW-93.

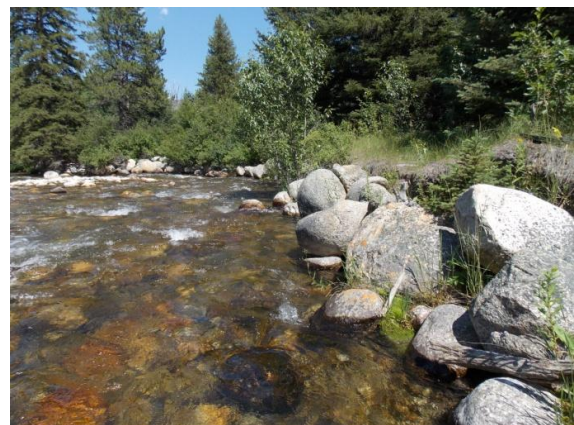
The river splits about 550 feet upstream of Site WF-4. Both channels run water yearlong although the north channel carries more water during base flows. The two channels are 300 feet apart at Site WF-4. Historic aerial photography indicates that the main river periodically shifts between the two channels and will probably continue doing so.

Rock rip-rap on the north channel of the West Fork.

Recommendation: Periodically check the “island” between the two channels to determine if active headcutting is occurring. If the north channel ever does cut through to the south channel, it will most likely be due to a headcut(s), not bank erosion.

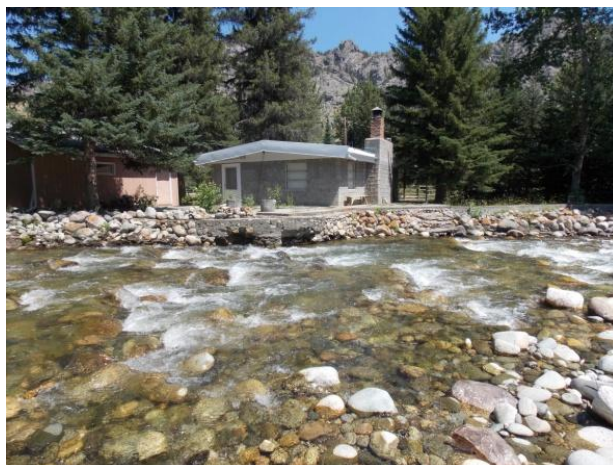
Individual small tract impacts to channel stability, in-stream flow, and water quality are usually minimal, but cumulatively they pose a significant risk to the West Fork Stillwater River.

House built on the floodplain next to the river's edge. A retaining wall and rip-rap have been built to minimize damage incurred during high water.

Recommendation: Develop and implement a small tract outreach and assistance program to help tract owners better understand how to minimize their impacts on the river. The program would include site-specific information on noxious weed management, water rights, septic maintenance, suitable building locations, riparian vegetation, and basic river dynamics.

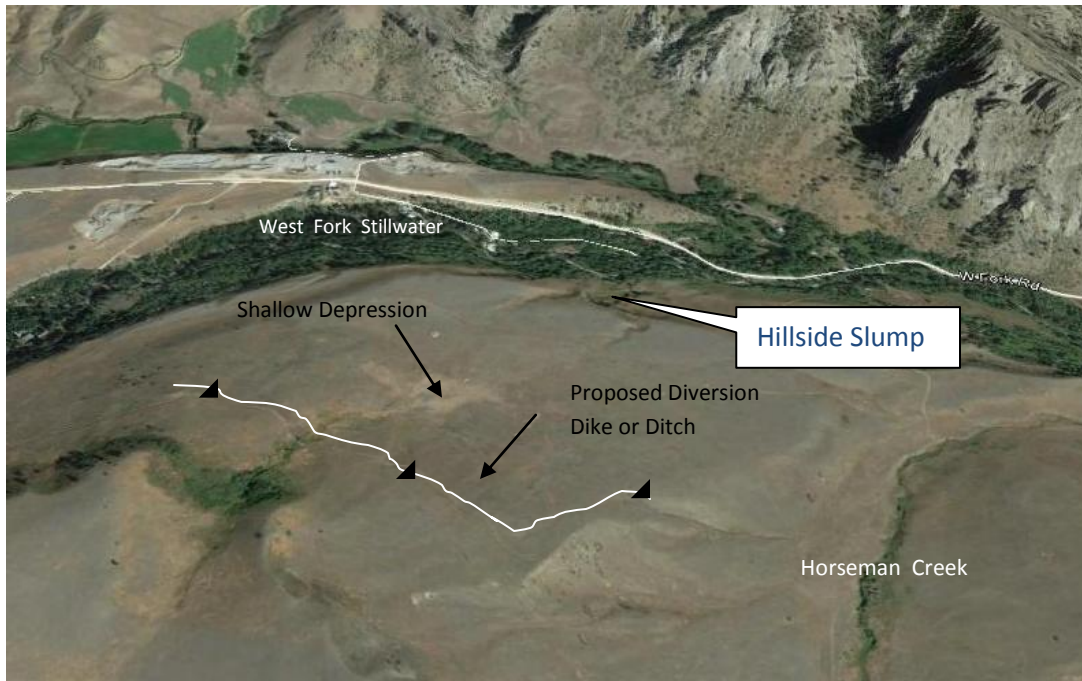
The hillside has glacial deposits overlying shale/sandstone bedrock. Natural precipitation and irrigation water can quickly percolate through the surface glacial materials (very fine clay to large boulders) eventually reaching the underlying shale or sandstone bedrock interface. The steep slope and water saturation of the glacial/bedrock interface may spur mass movement and unstable conditions. This scenario is common in the glaciated Stillwater and Boulder River drainages.

Most hillside slumping is relatively slow moving. The 1951 aerial photography shows little change over the last 60 years. Since the slump is slow moving, the river has the ability to remove the material as it reaches the river. That is not to say under saturated conditions, and perhaps in conjunction with seismic activity, the potential for abrupt and mass movement couldn't happen. It is unlikely, but certainly possible. The Berkley Subdivision tracts on the opposite side of the river could be threatened if such a scenario were to happen.

Hummocky surface on the hillside slump
at Site WF-7.

Recommendation: There is no assurance that the slump will not move in the future. It is a natural phenomenon common to the intermountain glaciated valleys of southcentral Montana. To slow future movement, the most cost effective option is to minimize water saturation in the slump area. All run-off from snow melt, heavy rains, and irrigation water should be diverted away from the slump area. The map below shows a possible route to divert run-off and irrigation water to Horseman Creek. The timing and frequency of flood irrigation on the bench above the slump is important in minimizing soil saturation.

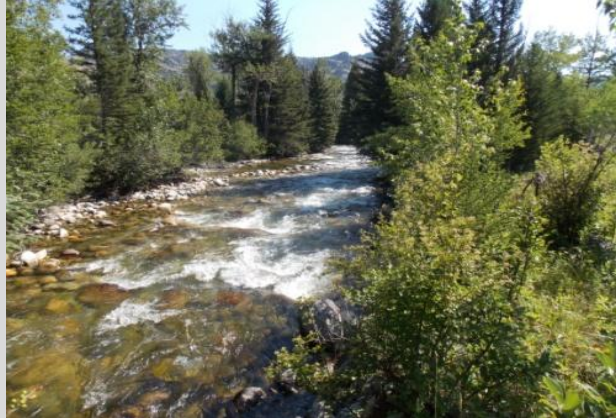
Naturally armored, boulder strewn river downstream from Site WF-5. The riparian vegetation along the channel is generally in excellent condition.

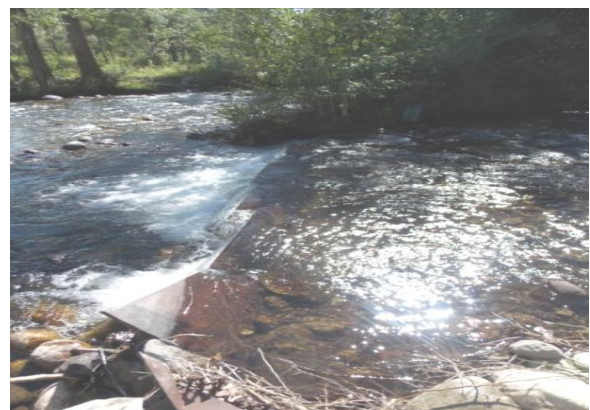
Old metal irrigation turnout and check structure located on the north bank of a secondary channel next to the West Fork Road. The structure, not used in over 20 years, once irrigated a 3 – 4 acre field down-valley. The turnout is an 18 inch diameter steel pipe with a grate to trap woody debris. The inlet has no water control gate. The steel plate check structure extends 20 feet across the channel and has a 2 foot drop. The conveyance ditch is filled in and no longer functional.

Old irrigation diversion: steel pipe turnout in the foreground and a steel plate check structure across the channel.

Recommendation: Remove the cross-channel check structure.

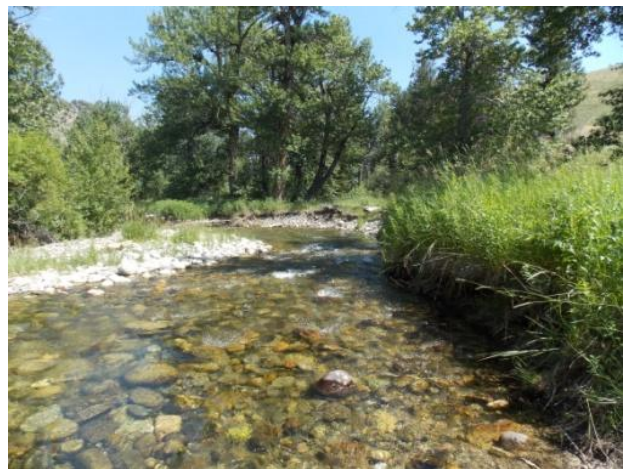
The West Fork River could recapture its old channel. The West Fork splits into 2 channels upstream from Site WF-11. The south channel carries less flow than the north channel. Horseman Creek (ephemeral coulee) enters the West Fork near an eroding bend on the south channel. If the bend continues to erode down-valley and/or if out-of-bank flood water creates a series of headcuts, the West Fork could recapture its old channel. The old channel tracks southeast entering the Stillwater River at Nye/Carter's Camp nearly 0.7 miles upstream from the current confluence of the West Fork. The West Fork hasn't followed its old channel in over 110 years. 1903 GLO maps show the river in its current location. No headcuts were found during the assessment. A preliminary survey indicates that out-of-bank flood water currently re-enters the West Fork and does not access the old channel.

Eroding bend on the south channel is shown in the background. An old river channel trace begins not far down-valley from this bend. Horseman Creek enters the West Fork on the right.

Recommendation: It is not likely that the river will revert to its old channel; however, the following recommendations would provide additional assurances that it will remain where it currently is:

- 1) Incorporate 2 – 3 small flow deflectors into the existing bank rip-rap upstream from the split channel to “encourage” the main flow to remain in the north channel.
- 2) Shape the eroding bend (100 feet) on the south channel to a 3:1 slope and armor with angular rock rip-rap. Form a low berm along the bend to divert Horseman Creek run-off away from the bank.
- 3) Construct a low dike (3 feet high x 80 feet long) about 100 feet down-valley from Horseman Creek to assure out-of-bank flows are directed towards the existing West Fork channel and away from the old channel.

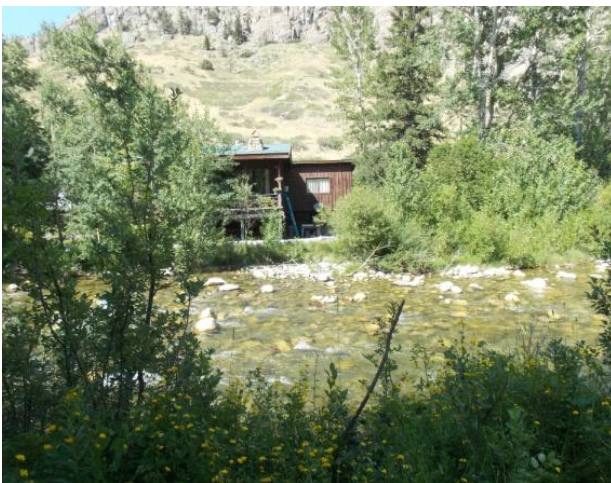
Individual small tract impacts to channel stability, in-stream flow, and water quality are usually minimal, but cumulatively they pose a significant risk to the West Fork Stillwater River.

House built on the low floodplain next to the river.

Recommendation: Develop and implement a small tract outreach and assistance program to help tract owners better understand how to minimize their impacts on the river. The program would

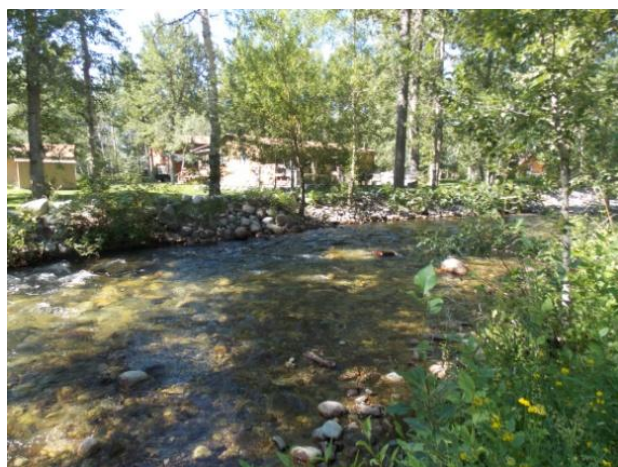
Individual small tract impacts to channel stability, in-stream flow, and water quality are minimal, but cumulatively they pose a significant risk to the West Fork Stillwater River.

House located on the low floodplain with rock rip-rap placed along the bank.

Recommendation: Develop and implement a small tract outreach and assistance program to help tract owners better understand how to minimize their impacts on the river. The program would include site-specific information on noxious weed management, water rights, septic maintenance, suitable building locations, riparian vegetation, and basic river dynamics.

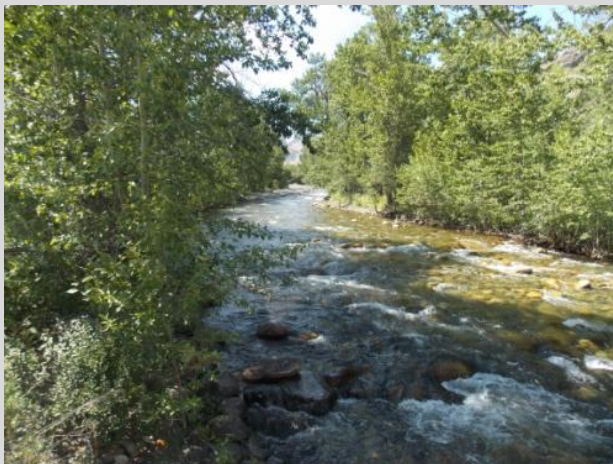
Single-threaded, cobble-lined channel with a densely vegetated floodplain. Photo taken near Site WF-13. The channel gradient gradually decreases as the West Fork approaches the Stillwater River.

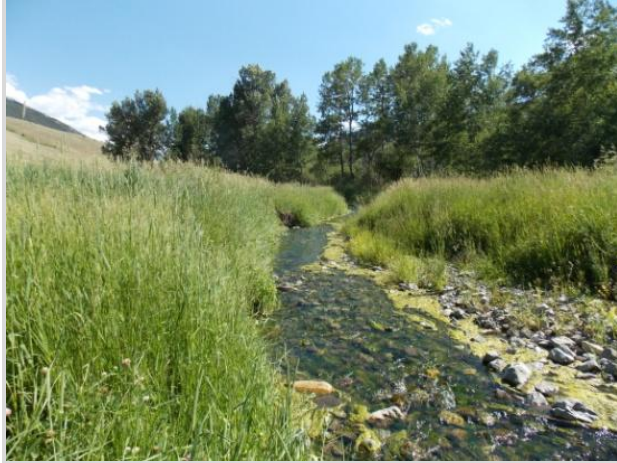
Lodgepole Creek downstream from Site LP-7. The channel is entrenched 2 – 3 feet creating some minor bank erosion. Algae covers much of the channel bottom in late summer.

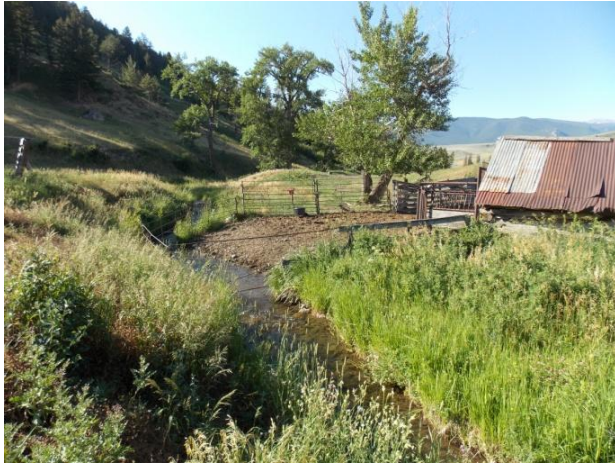
Small corral system located on Lodgepole Creek, downstream from the old town of Limestone.

Recommendation: Landowner is actively working with the local NRCS office to relocate the corrals and develop livestock water on higher ground.

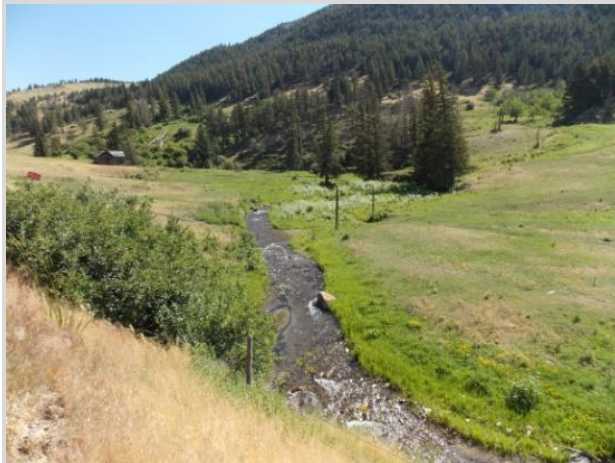
Lodgepole Creek upstream of Site LP-5. Riparian trees and shrubs are intermittent along this reach.

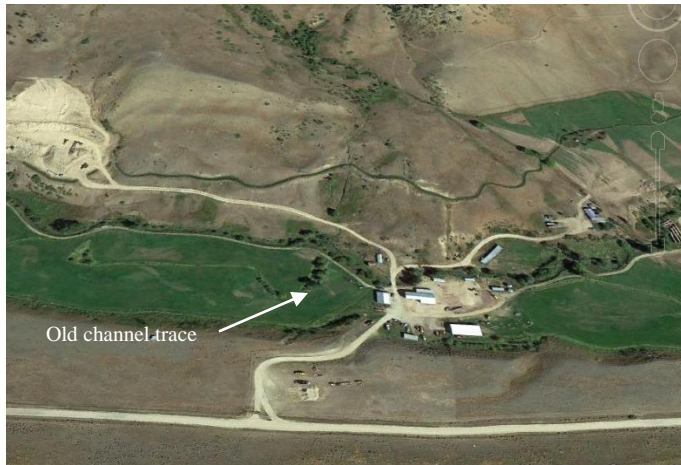
In the first half of the 20th century, the creek was probably moved to the north edge of the valley to accommodate hay production. 1907 GLO maps show the creek meandering further to the south.
